**Child Care Center  
PR0023ZZ**

**150 Chardon Ave., Hato Rey, Puerto Rico**

**Post-Earthquake Assessment**

**January 28, 2020**

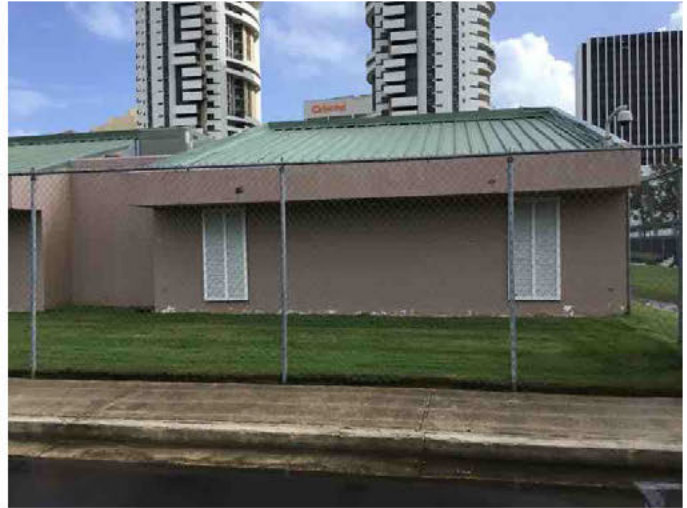
16 + 1/13/20

West facade.

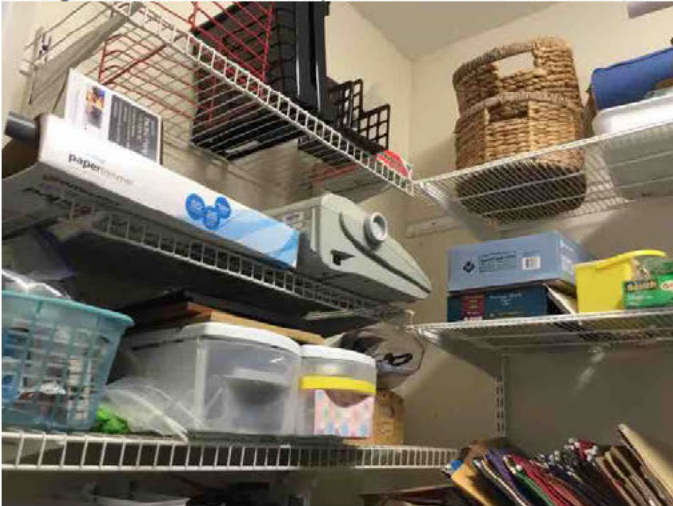
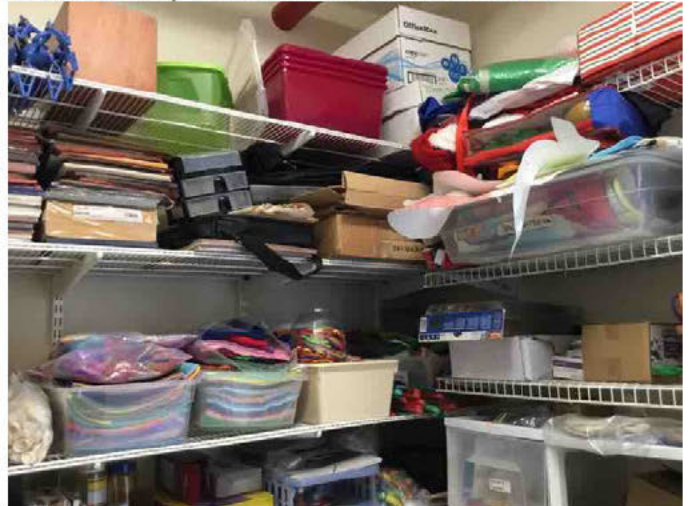
29 1/13/20

Storage rooms. This room requires closed cabinets attached to R/C walls. Heavy items to be located at lower shelves.

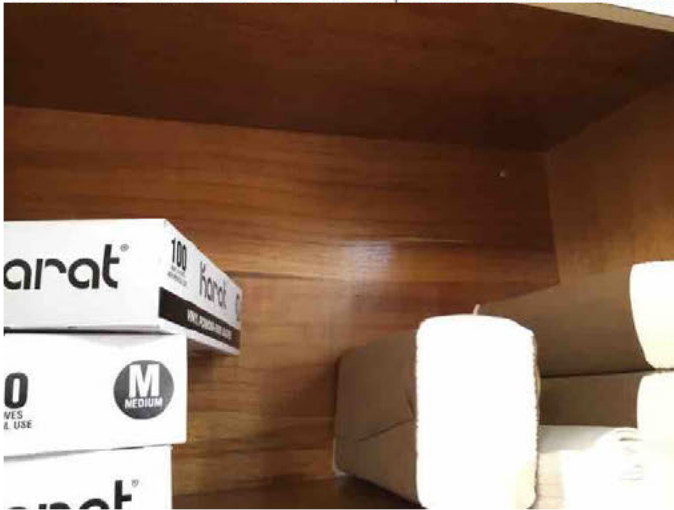
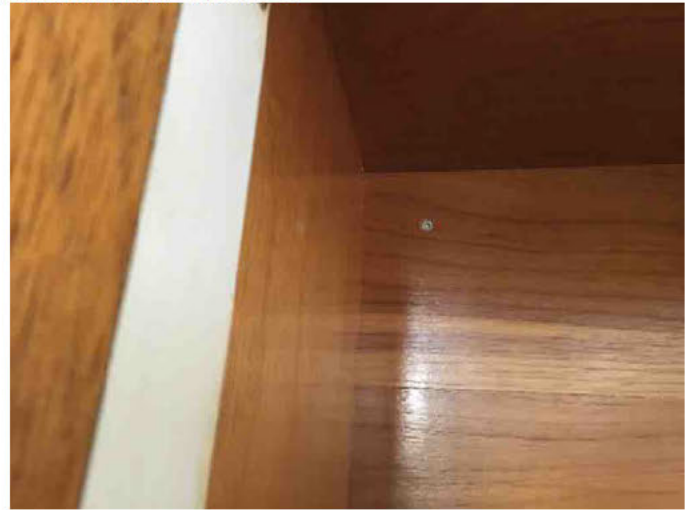
34 1/13/20

Classroom. The wooden cabinet requires additional screw bolts for attachment to R/C walls.
